Volume 33 No. 4
February 2024
S.A. Group
Newsletter

Our Editor is STILL battling with an annoying hum in an Astor radio that's under restoration. With the help of a fellow member, and a good book... he's on the trail to solving the mystery!!

The restoration from hell - An OTARI MX5050 MKIII-B2

Cover Story:

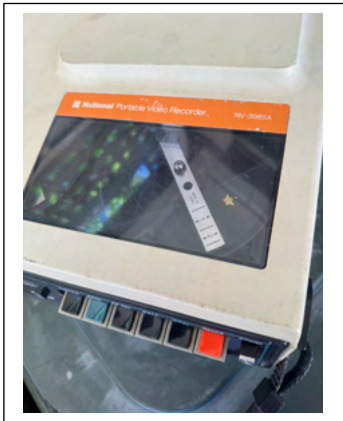
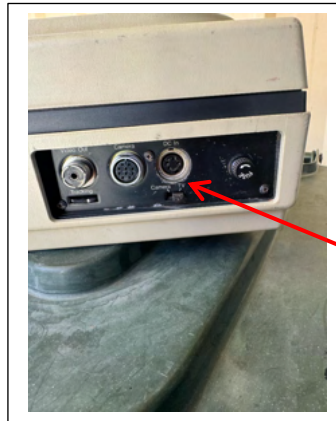
5. **WANTED TO BORROW:** A 12-volt power supply for National Panasonic Reel-To-Reel Video Tape Recorder, Model NV-3085A – Has a 4-pin din plug with a groove (see photos below) – Contact: Ian Smyth on 0488-488-776

Socket for 12volt
push-in power
lead.

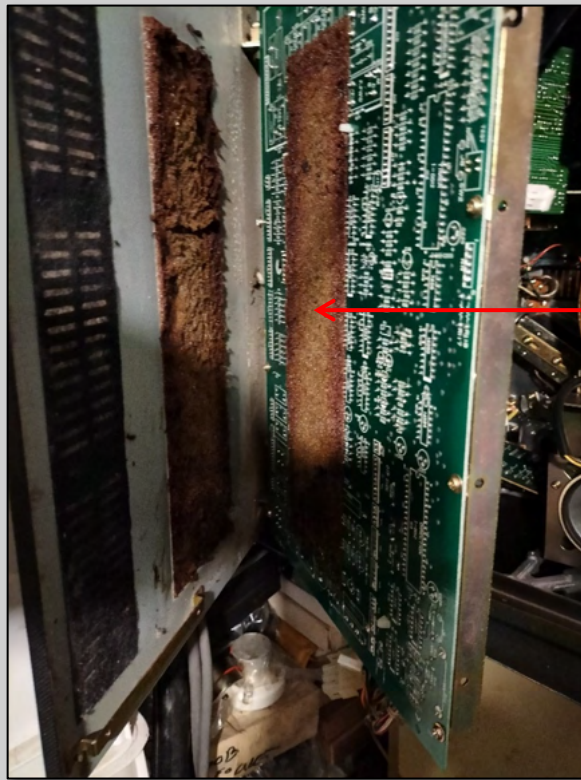
When powering up the recorder all deck controls were dead. The internal audio electronics were also dead except for the VU meters being illuminated! Nothing worked at all, not even some background noise. This I thought would just be a fuse or two. On opening the machine up it was full of dust, no blown fuses but the electrolytic capacitor innards were now leaking outwards! A foam spacer had disintegrated and deposited itself on the rear of the main control board.

Left: Main control board with foam spacer deposited on PCB

Access to the deck electronics and power supplies in these machines is by way of a swing out main board. 37 connectors later and you can remove the board for service.

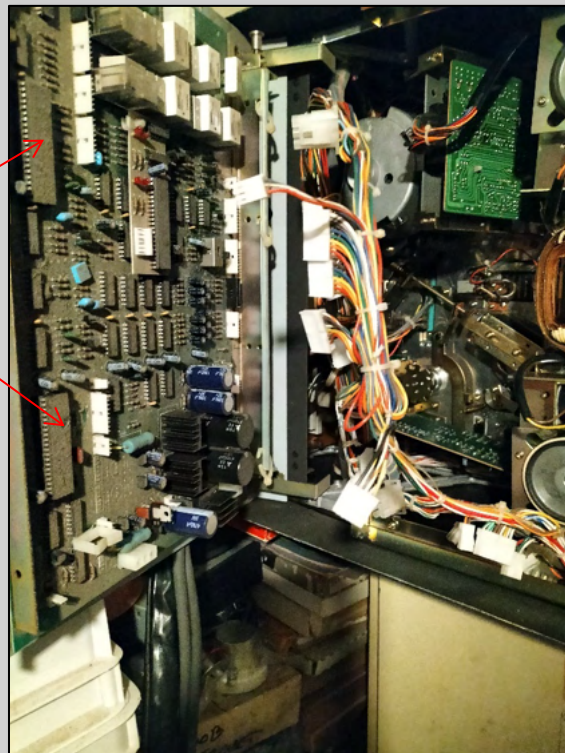
Right: Lots of accumulated dust coating components.

Once the main board was removed, all the disintegrated foam and the dust on the PCB was removed using acetone (Paint thinners) and \$2 a can of Supercheap degreaser. With a final dip in hot soapy water to remove all residues, it just needed a day or so in the sunshine before moving on to resolve the next problem.

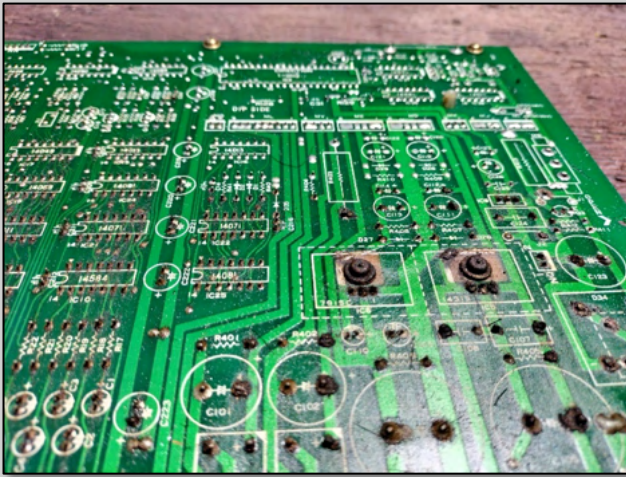
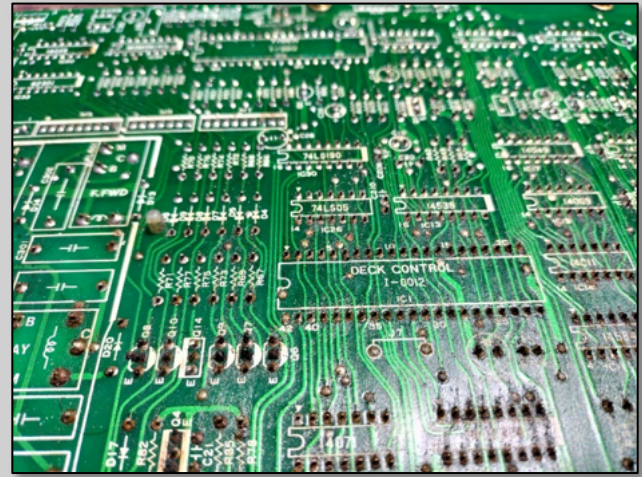
As the foam was hydroscopic it turned out that 90% of all the solder joints were now corroded away on the rear of the PCB. After much scrubbing with thinners and a toothbrush, I was eventually able to remove all the crud, but the solder joints were now *very* suspect. After coating the entire PCB with some spray flux, it was time to bring out the bench magnifier and resolder every connection on the PCB.

Above: Two “before” photo’s showing massive corrosion of solder joints

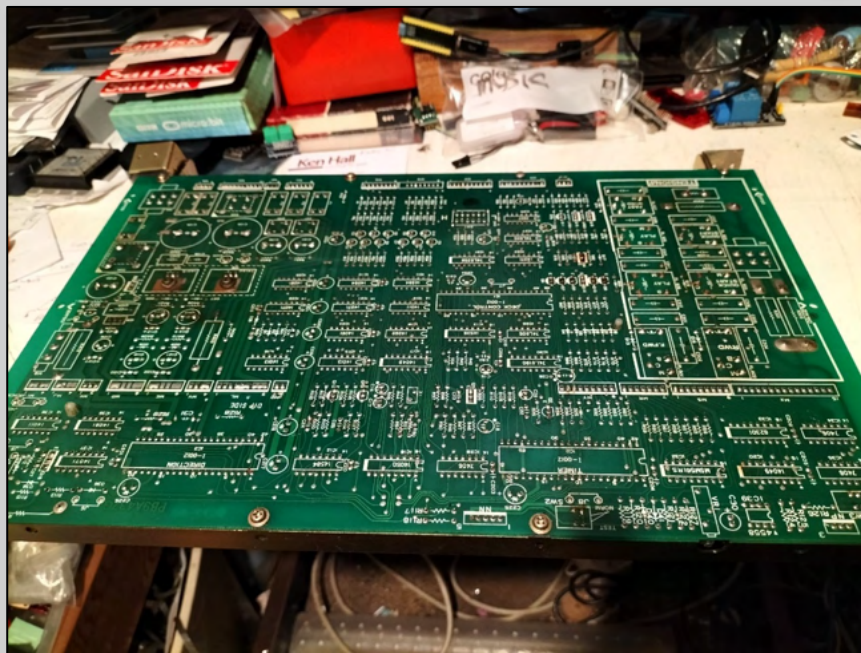
Above: “After” photo showing everything resoldered

After resoldering all connections and replacing all capacitors on the board it was a repeat process with cleaning the flux from the PCB using more thinners and hot soapy water.

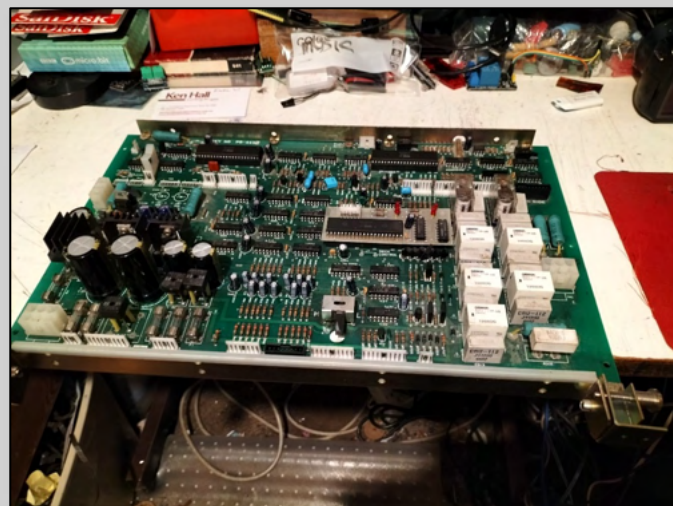
Above: Recapped PCB

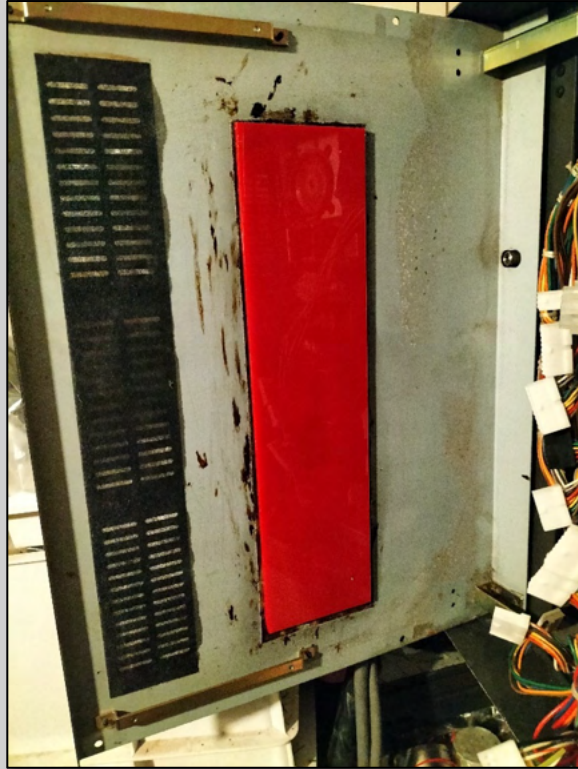
Below: Laser cutting a new 3mm acrylic spacer and removing the crud left by the old spacer was the next challenge, without doubt the acrylic one at least will not disintegrate in my lifetime.

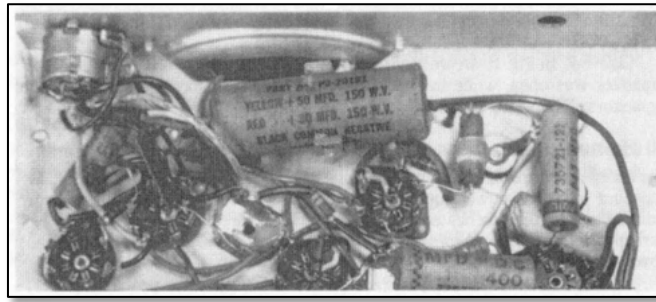
Fig. 10-1(B) The “All American Five” under-chassis showing a brown cardboard dual-section electrolytic capacitor.

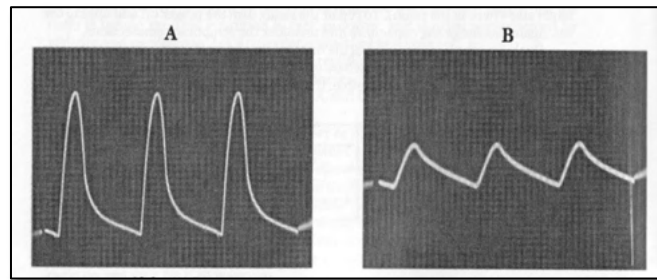
This radio had not been turned on in many years, so both sections of the dual electrolytic capacitor were open. Figure 10-3A shows the waveform across input filter capacitor C1A when C1A was defective. Note the extremely high ripple. When the new replacement filter was installed, the ripple dropped to the level shown in Fig. 10-3B. Likewise, in Fig. 10-4A we see the ripple waveform across C1B when the filter

Fig. 10-3 A (left) shows ripple at output of rectifier with a bad filter. B (right) shows with a good filter

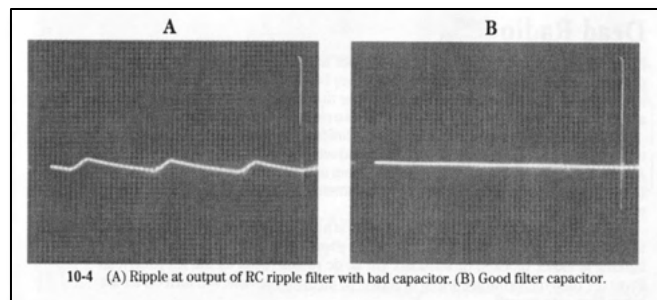
capacitor was open, while in Fig. 10-4B shows the waveform when both filter capacitors are working properly.

Fig. 10-4 A (left) shows ripple at output of RC ripple filter with bad capacitor. B (right) shows good filter capacitor.

An oscilloscope can also be used for locating the defective section. Use the scope in the AC-coupled input mode and adjust the vertical attenuator to show a reasonable trace on the screen. Figure 10-3 shows the before and after waveforms at point A across capacitor C1A. Figure 10-4 shows the waveforms at point B, across capacitor C1B.
